APPLICATION OF LINE SURGE ARRESTERS TO A 110 kV OVERHEAD LINE IN AN AREA WITH HIGH LIGHTNING ACTIVITY

Abstract: Line surge arresters (LSA) may reduce temporary line outages and problems in overhead line networks caused by atmospheric discharges such as lightning. Although the usage of LSA is already common practice in several countries, this project is the first installation in Austria at the 110 kV level.

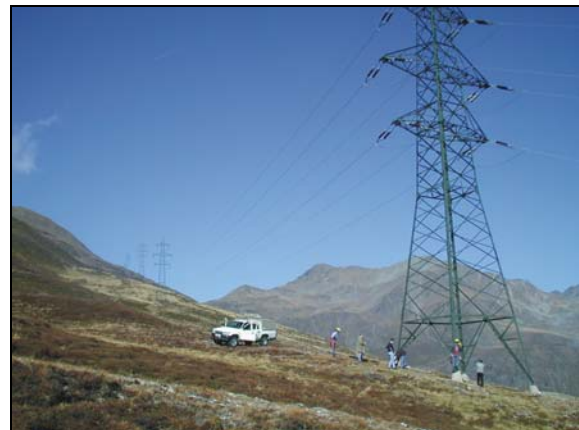
Figure 1: The studied, high alpine overhead line

The studied line lies in a mountainous area in the south of Austria. Along its almost 30 km long route, it passes the Krezueckgruppe at around 2300 meters above sea level. Long parts of the line are situated above the timber line in areas with rocky soil.

The tower footing resistances along the line can reach values up to 1100 Ω . Originally, the overhead line was constructed as a double circuit line with one shielding wire at the tower top. The line consists of 108 steel towers with span widths from 120 m to 493 m (median: 266 m).

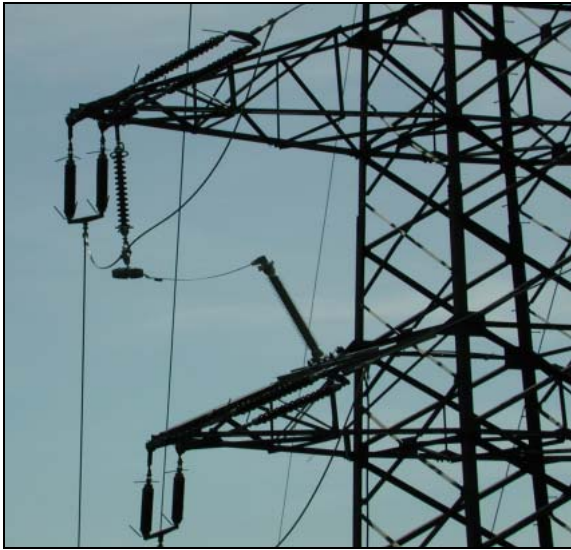
Figure 4: Application of a line surge arrester on a dead-end tower (arrester located at bottom cross-arm)

The line location holds additional aggravating circumstances – It is not possible to access the line during the winter season at all. Therefore, it had to be secured so that with the implemented protection scheme an unhindered line operation is possible at all times, even in case of the failure of an arrester or one of its components. Eventually, modern gapless metal-oxide surge arresters were implemented. In total, 18 surge arresters were deployed on 9 towers (2 LSA per tower). The connection between LSA and phase wire was made with a flexible line that was protected with a disconnection device. This device separates the phase wire from the arrester in case of component failure.
