Correlative Raman-SEM-EDX analysis of corroded components

In particular microbiologically induced corrosion (MIC) of steel and chlorid corrosion of concrete

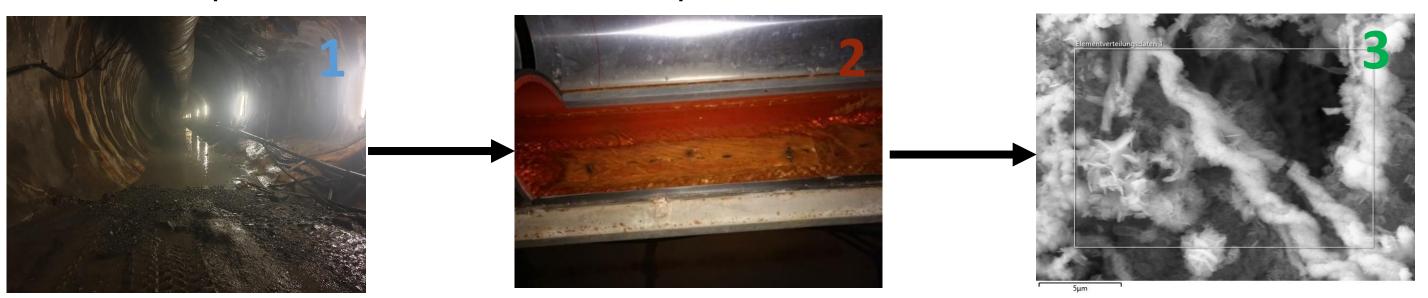
During experiments in the Koralmtunnel (1) iron oxidizing bacteria were found to be part of a biofilm (2) producing microbial community dominated by a variety of eubacterial methanotrophs. Microbial community analysis (16S profiling and metagenomic studies) from biofilm samples revealed the presence of different species from the family of Gallionellaceae (3). The flow of electrons from Fe++ is used by autotrophic bacteria such as Ferriphaselus sp. to generate energy e.g. for CO₂ fixation processes and concomitant production of biomass.
