Pre-breakdown behaviour of oil-board-arrangements under lightning impulse stress

W. Lick, M. Muhr

Institute of High Voltage Engineering and System Management
Graz, University of Technology
Inffeldgasse 18, A-8010 Graz
e-mail: lick@hspt.tu-graz.ac.at

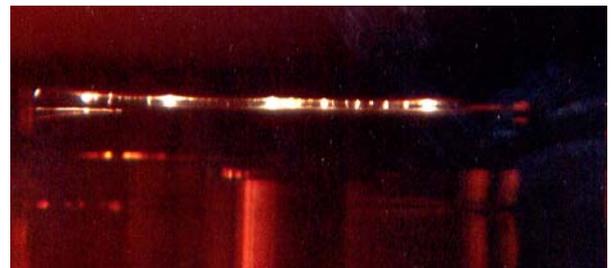
Figure 5: pre-breakdown in the test vessel

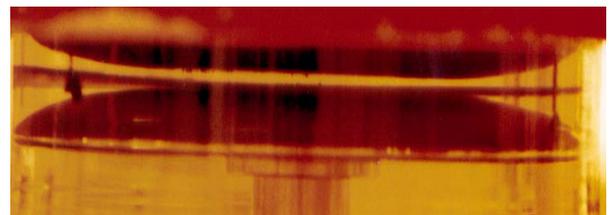
Figure 6: bubbles in the oil gap after pre-breakdown

At the beginning of the impulse test the new board specimen was conditioned with alternating current of about 50% of the partial discharge onset voltage. This voltage (about 20 kV) was maintained for 20 minutes. Then the impulse test starts. The impulse voltage was raised up in 5 kV steps beginning with 130 kV. The impulse curve was recorded by oscilloscope and the test arrangement in the glass vessels was optical observed, therefore the test hall was darkened. Figure 3 shows a typical impulse curve on the oscilloscope screen. At this impulse no visible discharge at the test arrangement occurs. Figure 4 shows an impulse where optical visual pre-breakdowns in the oil-board-arrangement appeared, figure 5. If ones compared figure 3 and figure 4 there is no significant difference, which means that pre-breakdowns are not detectable by the conventional impulse measuring technique. In figure 6 the effect of pre-breakdowns, bubbles in the oil gap, is visible.
